SEDGWICK PARISH COUNCIL CANAL REPORT

November 2024

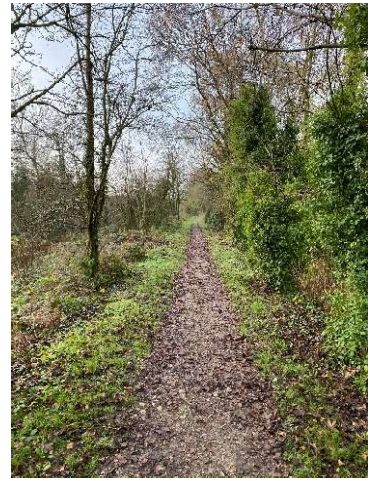
Paths: Paths are full of recently fallen leaf mould – it is hard to tell where the repairs are needed at the moment as they are quite clear but we will need to mark the patches as soon as it becomes evident. The steep path was not slippery when I inspected but we need to monitor especially the rail.

Patch Path and steep path

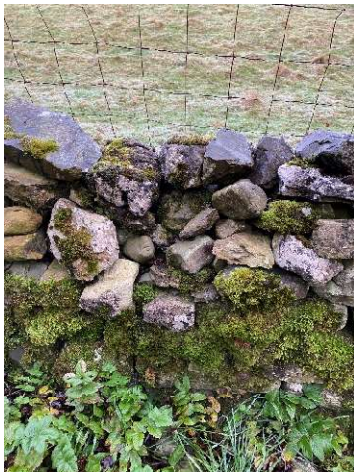
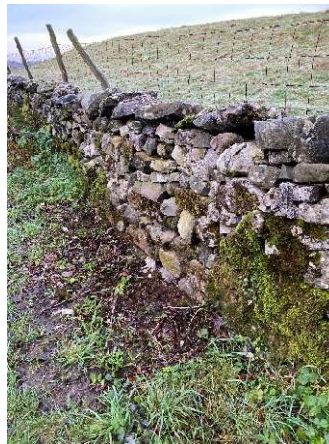
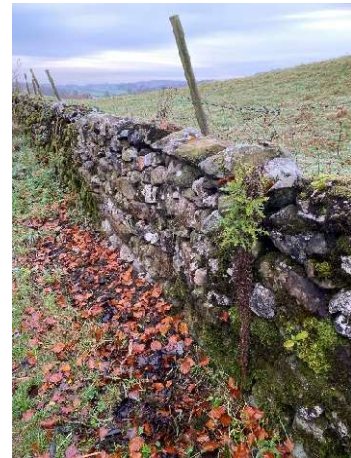
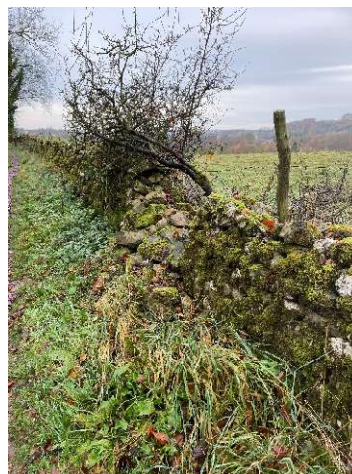
Boundaries, Walls and Fences – Mr Simpson has been to repair two sections of the wall – the long stretch and the shortest. Both repairs look excellent. This only leaves the part pushed over by the sloe tree and the minor repair slightly before it.

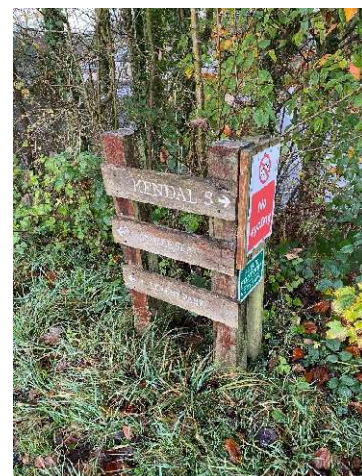
Signage: All are sturdy but the waymarker needs a re-varnish.

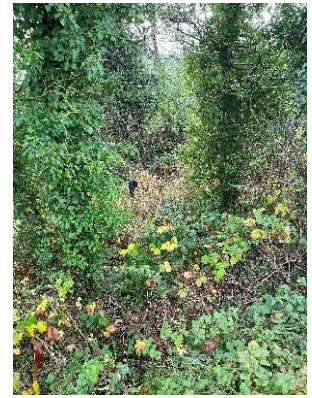
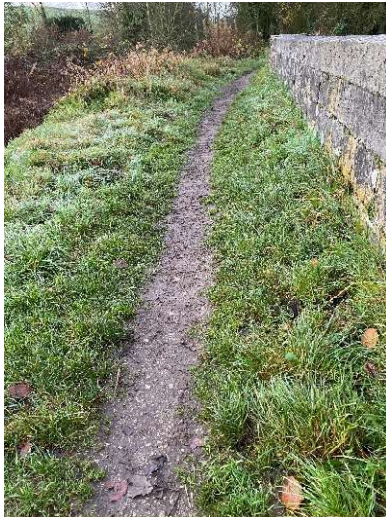
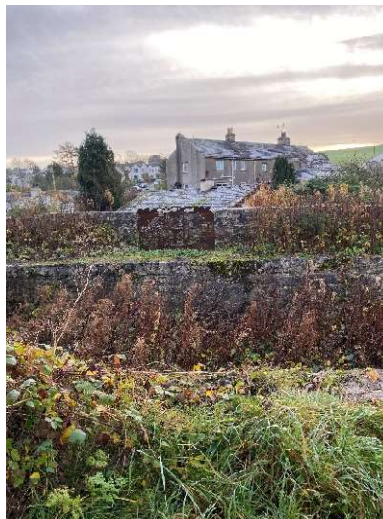
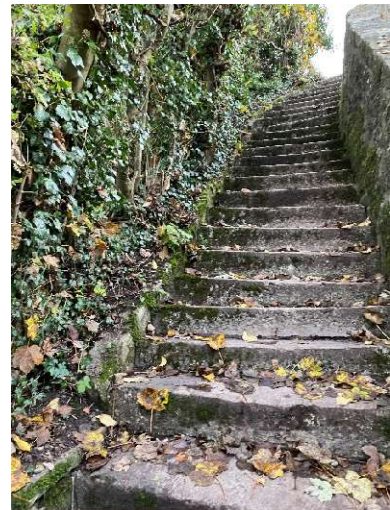
CRT: It looks like some maintenance may have occurred- the vegetation around the art installation has been chopped back as has the sycamore vegetation up the aqueduct steps – it is unknown who carried this out but the steps are now passable. The path over the aqueduct is already the muddiest part of the whole stretch.

PS the signage at the foot of the aqueduct will need a re-varnish in the Spring – I have added and appeal to the Xmas newsletter.
